Home Inspection Report For John & Jane Client 123 My Street, Your Town, Il. 00000

John & Jane Client

10/20/2006

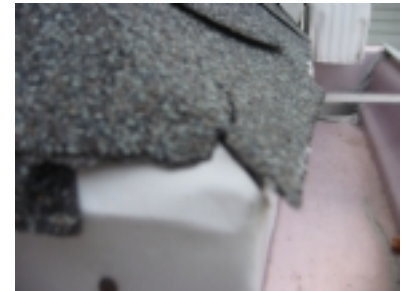
Picture Date:10/20/2006

Main Roof:

REPAIR or REPLACE - Mechanical / physical damage is present. In my opinion this can allow water leakage and water entry into the building. Water leakage can lead to various problems including damage to plaster, drywall, flooring and can lead to a mold problem. I recommend you contact a qualified roofing contractor for appropriate corrective action.
